PROJECT: CONSTRUCTION OF A SECONDARY SCHOOL FACILITY AT CAMPBELL TOWN COMMUNITY, WESTERN AREA RURAL DISTRICT

Monthly Progress Report NR 05

Aug 3rd 2021

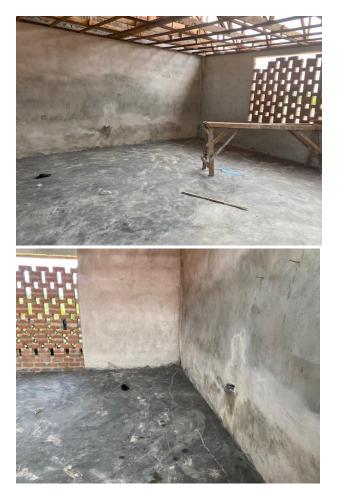
Photos Showing Plastering and Screeding Works in all classrooms, offices and Computer room and library
